AWESIM Pty Ltd
 PO Box 442 Moorebank NSW 1875
 0419 600063
 ABN 95 074 479 762

Pre Purchase Building Inspection

Client:	Mr John Brown		
Contact Details:	Ph. 09 999 1234	Email: j.brown@abcinc.comm.au	
Report No:	Sample Report		
Inspection address:	5 Lanagan Ave, Sydneyville, NSW, 2000		
Inspection Date & Time:	22, June 2012 1:30 PM	Arrival time:	1:30 PM Departure time: 3:45 PM
Weather Conditions at time of inspection:	@ start Overcast	Temperature:	20
Inspectors Name:	Glen Sim	License No.	Bld Lic # 232673C
Inspectors Email:	glen@awesim.com.au		
Inspectors Phone No.	0419 600063

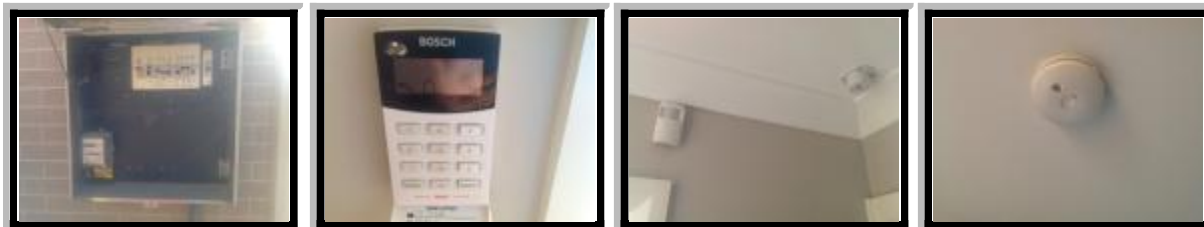
Main Panel: Unit appears to be new / original condition
 Main Panel: Circuit Breaker labels are missing / incomplete / Illegible. (2) (6)
 Smoke Detectors: Tested smoke detector, found to be working correctly
