Owner Builder Defect Report

Front Elevation of the Inspected Property

| Report No: | OB140115 | | |
| Inspection address: | 2A Ross Street, Seaforth, NSW, 2092 | | |

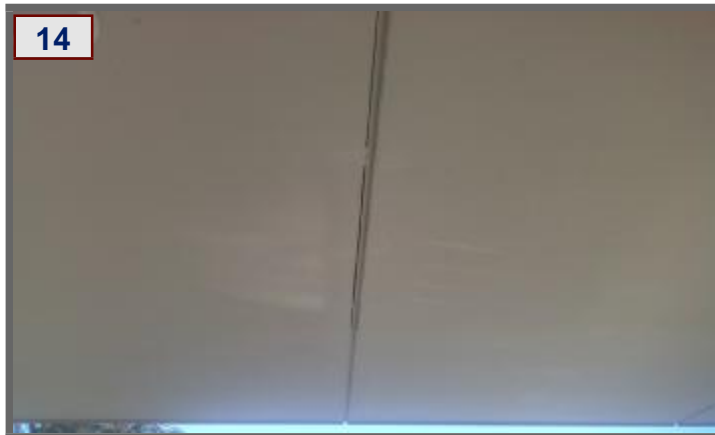
Cracking to soffit lining of Rear left Bedroom Balcony

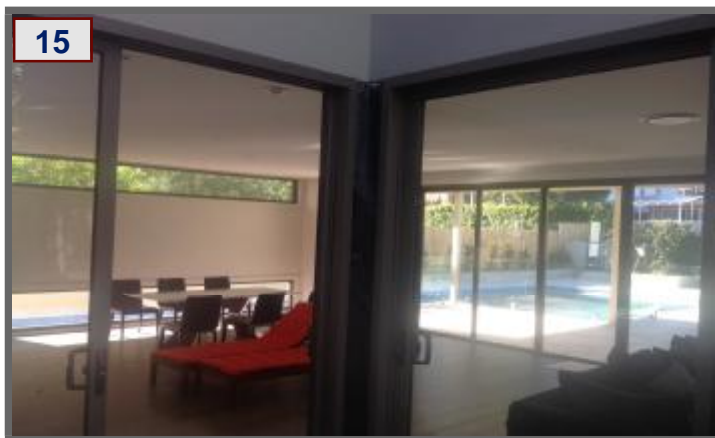
Incomplete flashing between windows

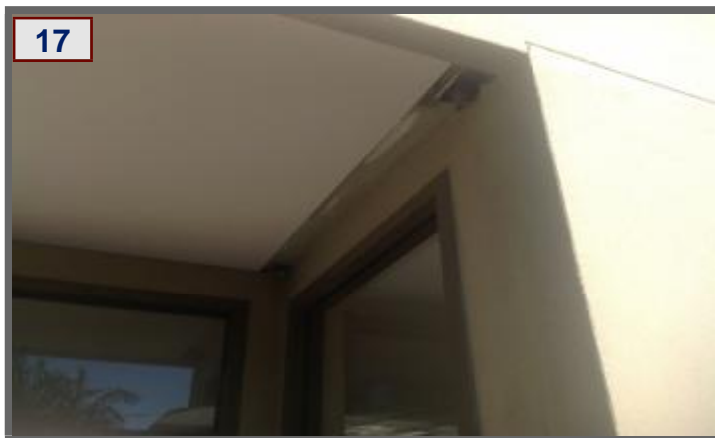
Exposed steel beam post support & nuts & bolts

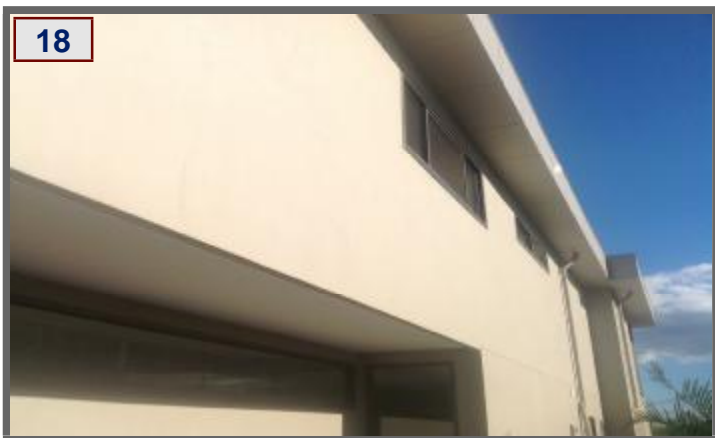
Right Hand Side - Exposed sheet joints to 2nd level

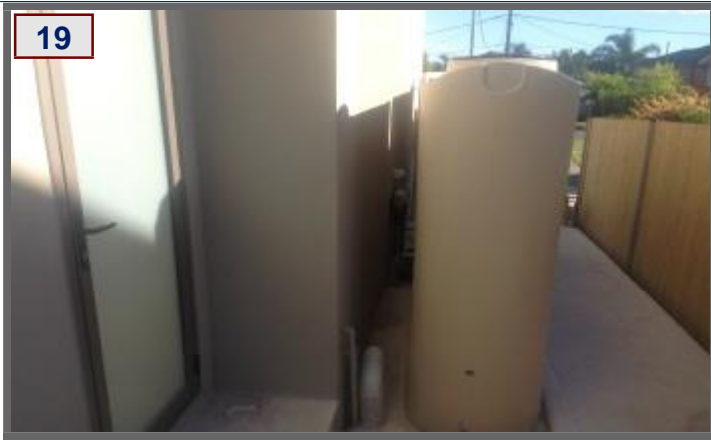
19

Water Storage Tank Not Installed, Incomplete render

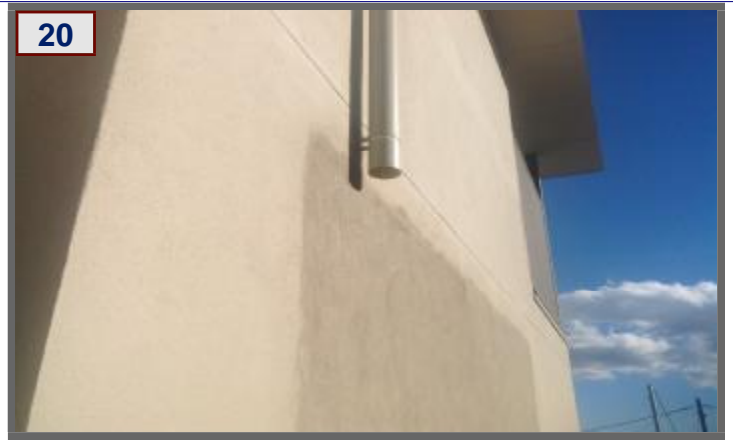
20

Wall above water tank, down pipe not connected

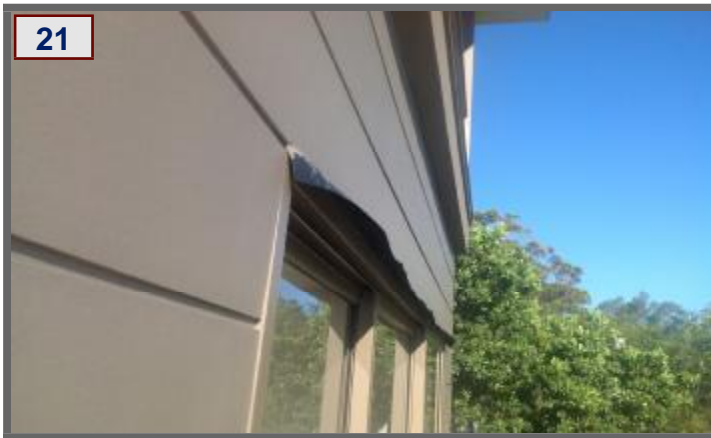
21

- Window Flashings: All other window heads have the cladding butting to the window head, installed without an over flashing that passes over the front edge of the windows. Water may drain to the ends and cause possible water egress & damage to the frame at the ends of the windows & doors. (1)(4)

Flashings above windows - Incomplete

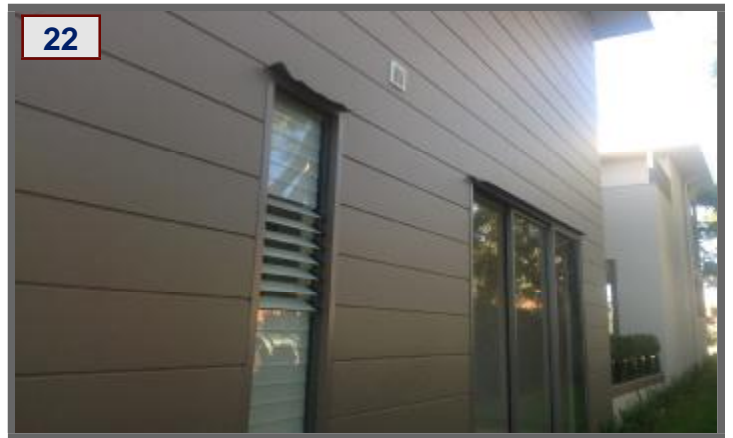
22

Incomplete - Flashings above windows

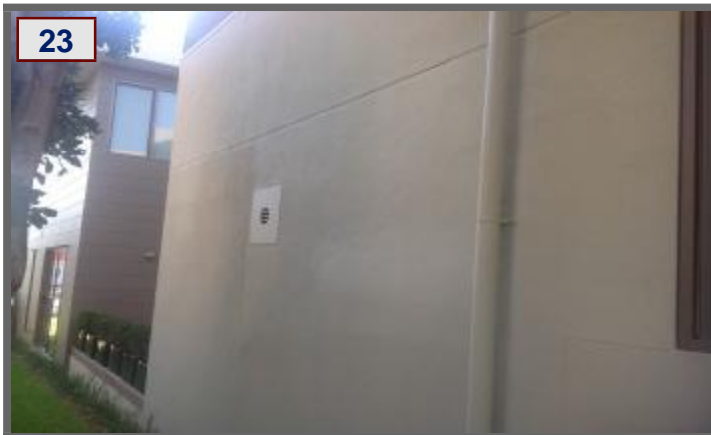
23

Inconsistent Text & painting to wall - Left Hand Side

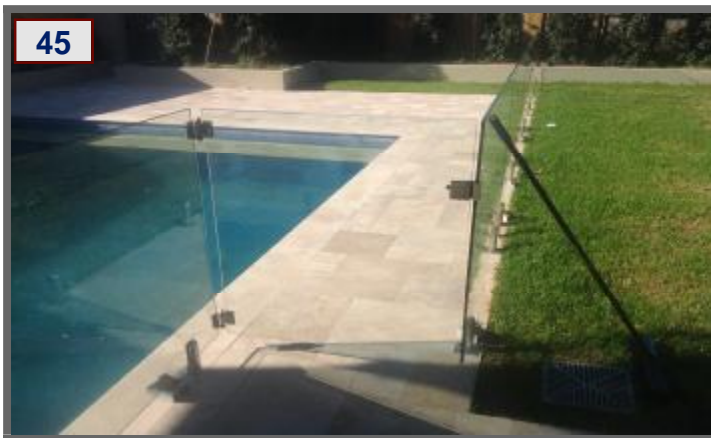
Pool Gate does not self close

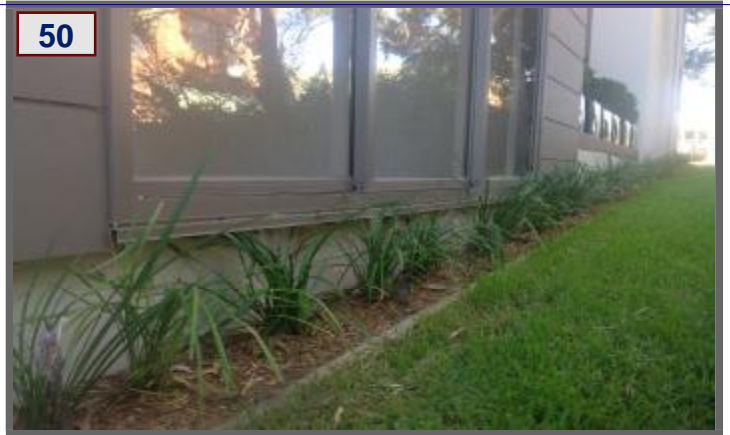
Not support under window

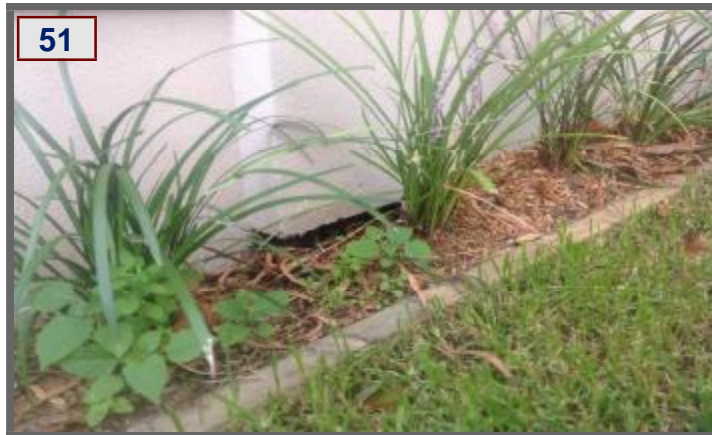
Blue Board in contact with the ground

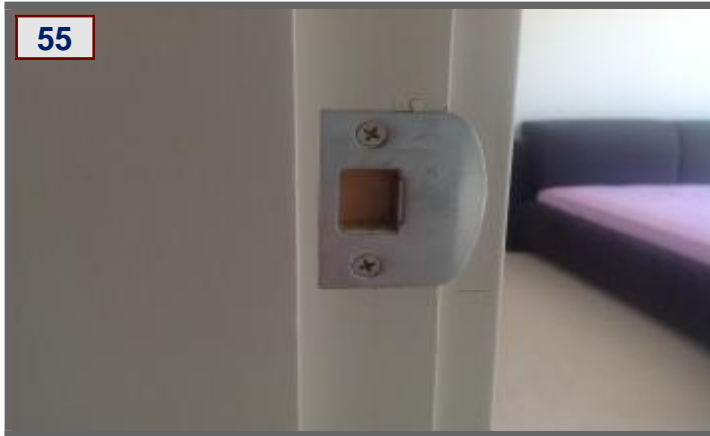
55

Door Striker holes not painted

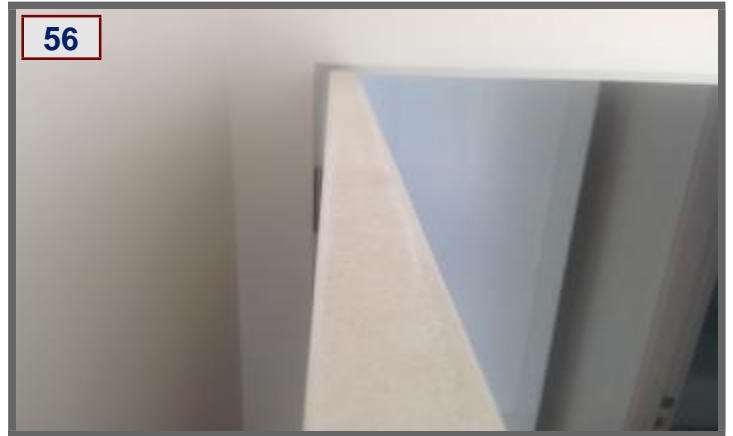
56

Tops & Bottoms of doors are not fully painted

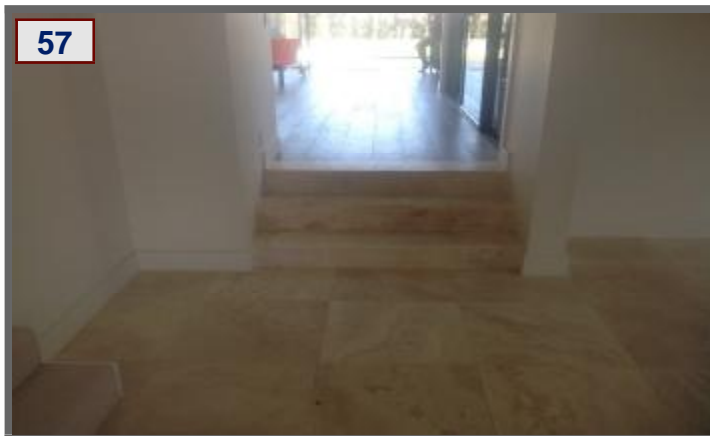
57

Inconsistent riser heights

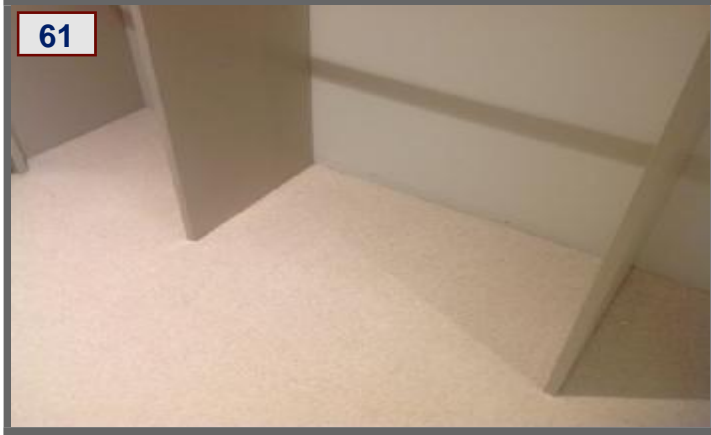
Skirting Missing to Bed 1 WIR

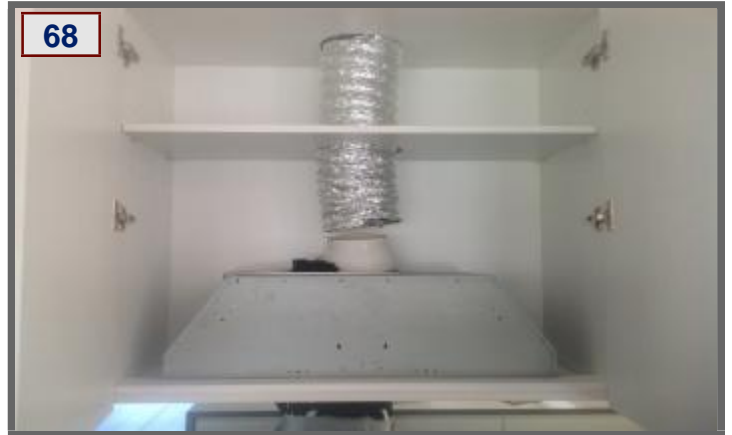
- Top drawer under cooktop does not close, hitting gas inlet (2)
- Ranghood: Duct not complete (2)
- incomplete wiring inside cupboard above left of range hood & above sink (2)
- exposed gas service to butlers kitchen (Note)
- Missing push open to cupboard door above oven(2)
- Holes in back of drawers under oven(2)
- kick panel under dishwasher not fitted correctly(2)
- Butlers Pantry/Laundry: incomplete caulking to benchtop, both sinks not hooked up - Laundry tub & kitchen sink (2)
- Butlers Pantry/Laundry: With a cooking & laundry area in the same room, check if this combination passes the Australian Building Code(4)

Rangehood duct not connected

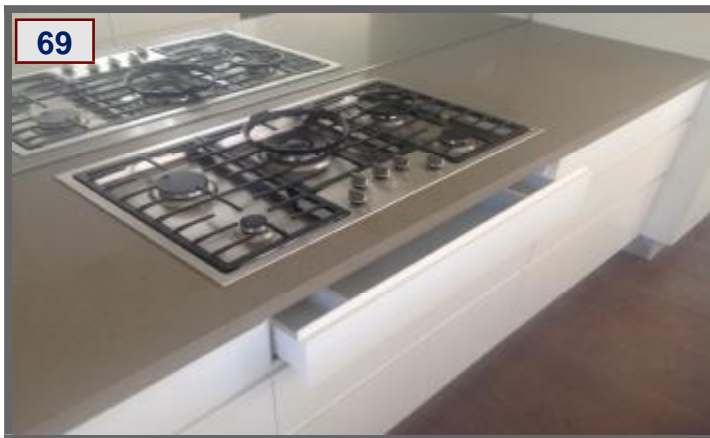
Top drawer under cooktop does not close

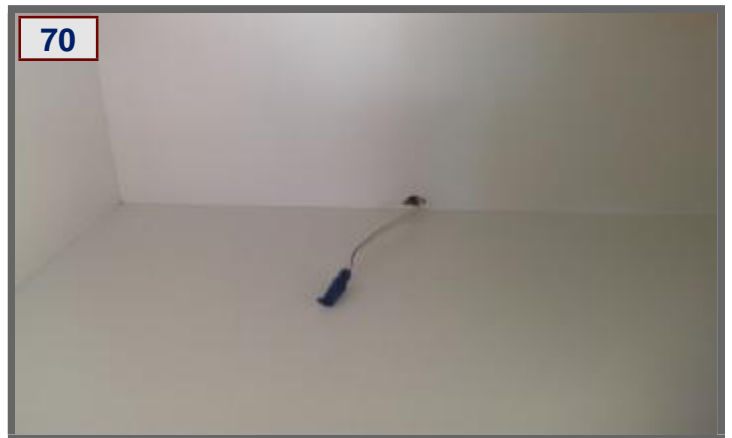
Exposed electrical wire

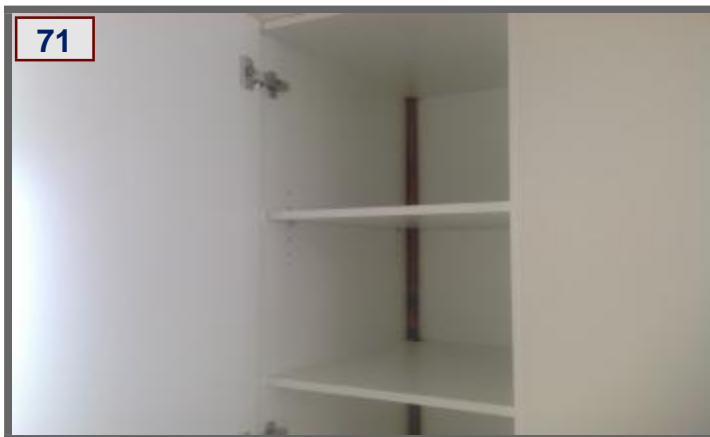
Exposed copper gas pipe

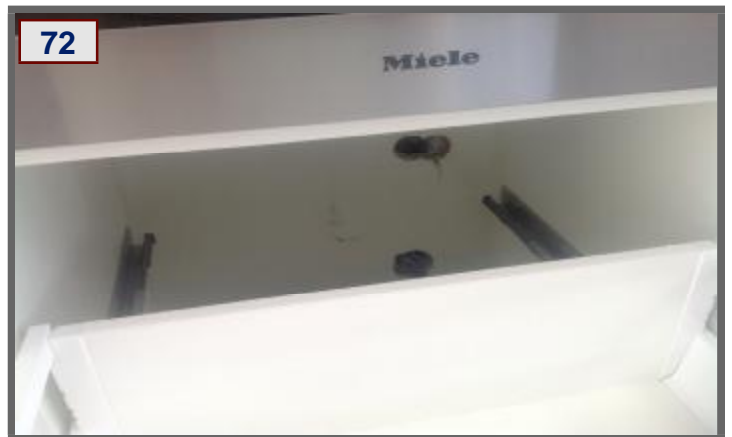
Holes in wall under oven

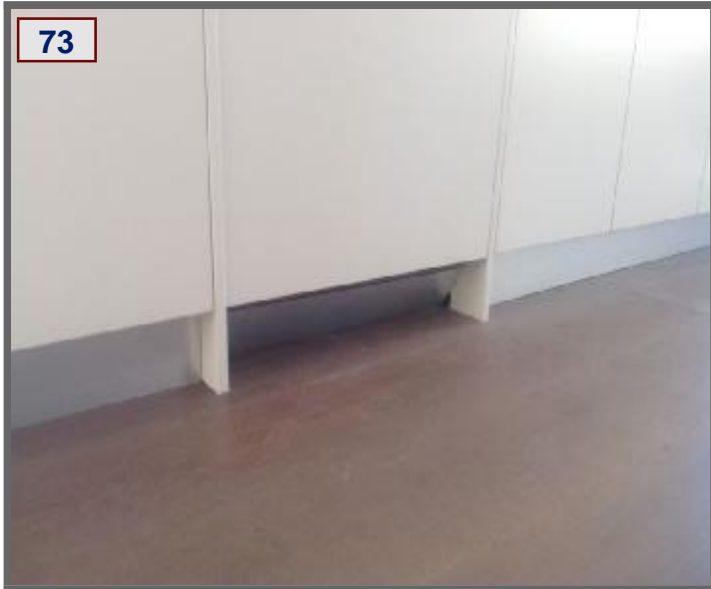
Kick panel under dishwasher not secured

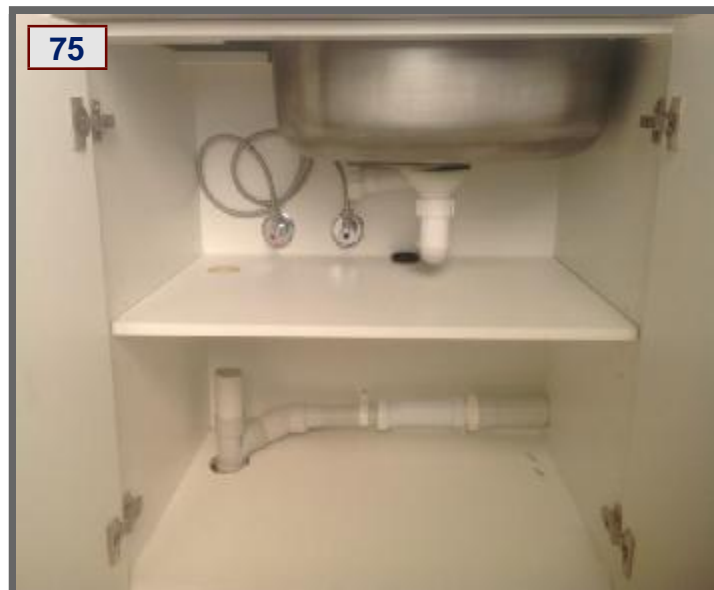
Laundry tub not waste not connected

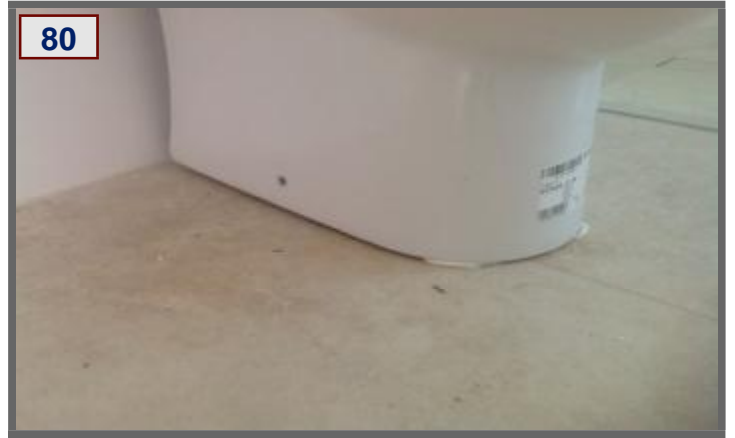
- Downstairs Bathrooms: Water ponding in shower, no angle water stop to step into shower (1)(4)
- Downstairs Bathrooms: The toilet is not secure (2)
- Upstairs Bathroom: shower Ponding water (1)(4)
- Ensuite: The shower door hits the overhead shower rose (2)
- The bathrooms were tested with a moisture meter, however the bathrooms and showers have not been used, so the tests and results are inconclusive, requires further investigation (4)

Toilet not secure

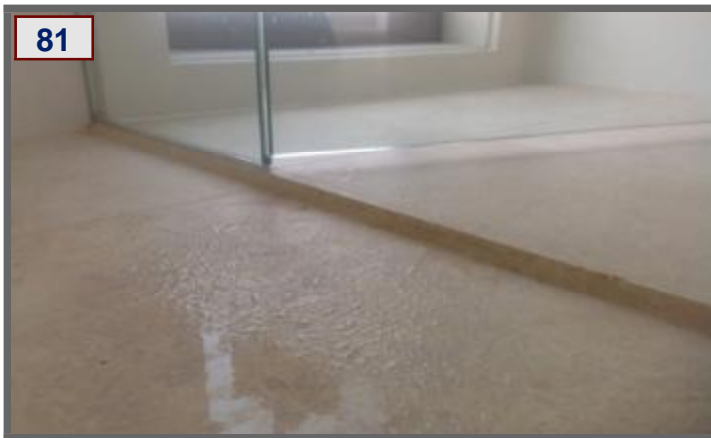
No exposed water stop

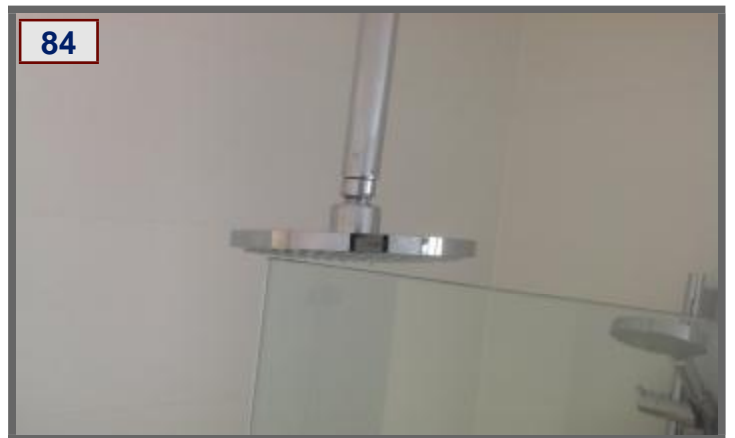
Door hits shower rose

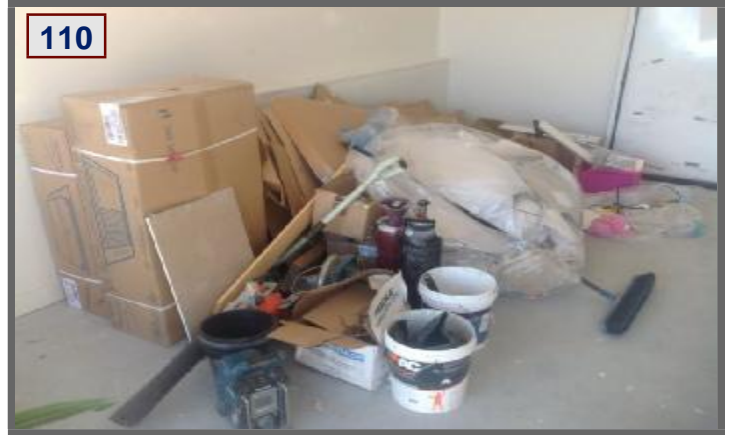
Rubbish in Garage

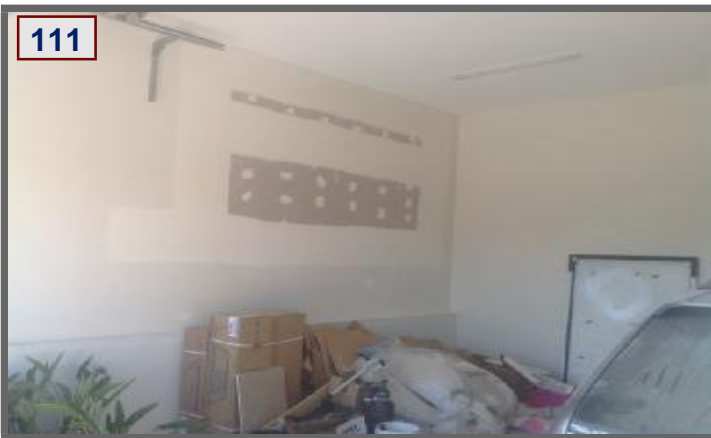
Newly plaster wall

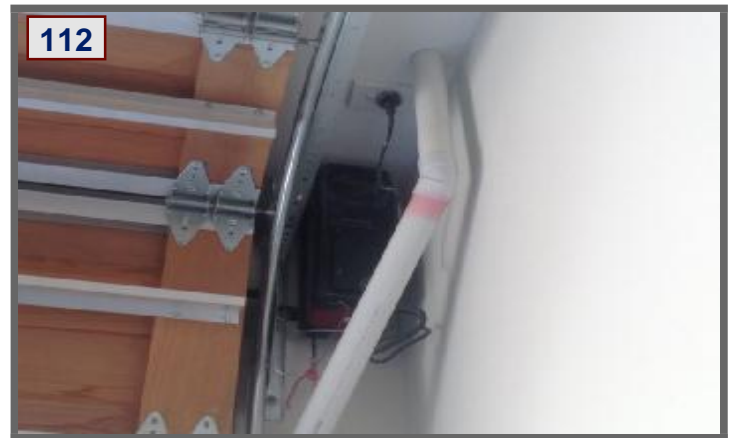
The vertical PVC pipe on either side of the garage door is not secure, possible stormwater pipe from balcony above (2)
On the RHS of the garage door, on the ceiling, there is a large hole in the ceiling around the PVC pipe, (2)(4)
Wall: The LHS wall, there has recently been extra works performed, at the time of the inspection i found approxiamately 4m long x 2m high newly installed & set plasterboard to the wall. Painting incomplete (2)(4)

PVC pipe not secure
